DESCRIPTIVE REPORT

Type of Survey ... Field Examination

Field No. . . . PE-5-1-85

Sublocality West Gregerie Channel

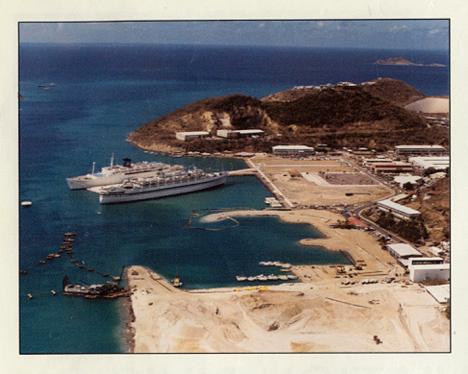
CROWN BAY PORT

LOCATION: St. Thomas, U.S. Virgin Islands

Phase II-B

- 750' Dock for Cruise Ship
- 100 plus Pleasure Boat Marina

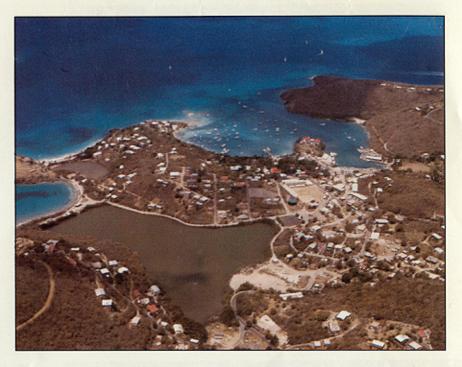
CRUZ BAY - ENIGHED POND

LOCATION: St. John, U.S. Virgin Islands

EnightedPond:

- Marina
- Dry storage
- Charter Boat Docks
- Cargo Area with Storage for Bulk Materials
- Park and Recreation Area
